C.A. PRETZER ASSOCIATES, INC. 50 Freeway Drive, Cranston, RI 02920

August 10, 2011

Jamestown Golf Course Building 245 Conanicus Avenue, Jamestown, RI CAPA File No. 211686.20 Structural Assessment

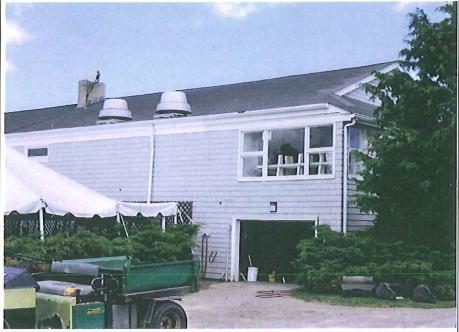
Photo 1

The exterior façade of the Jamestown Golf Course building is primarily finished with painted cedar shingles, refer to photos 1 to 5. The cedar shingles appeared to be in good condition, except in areas where the window casings have cracked and failed, and water has infiltrated, causing some slight rot to the cedar shingles.

Southwest corner of Jamestown Golf Course building.

Install new thermopane replacement windows in all locations where there are original singlepane windows. Repair and replace any rotted window framing or exterior shingle siding in these locations.

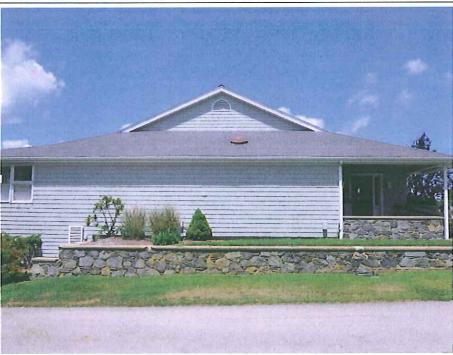
Photo 2

South elevation of Jamestown Golf Course building.

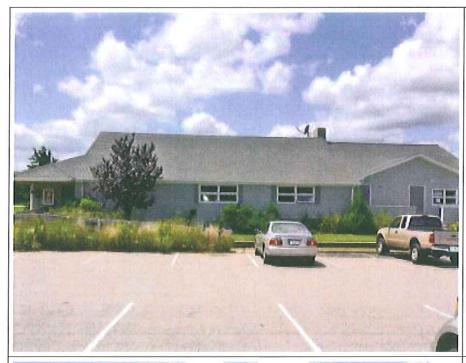
Photo 3

East elevation of Jamestown Golf Course building.

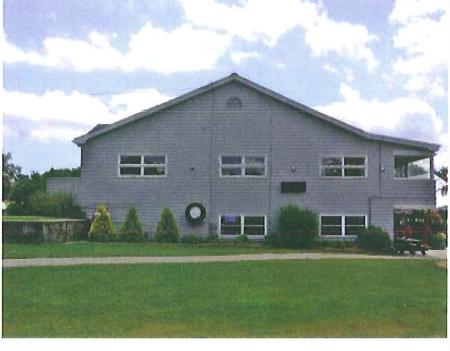
Photo 4

Northwest corner of Jamestown Golf Course building.

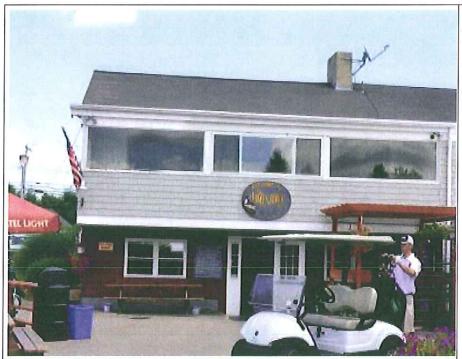
Photo 5

North elevation of Jamestown Golf Course building, at restaurant.

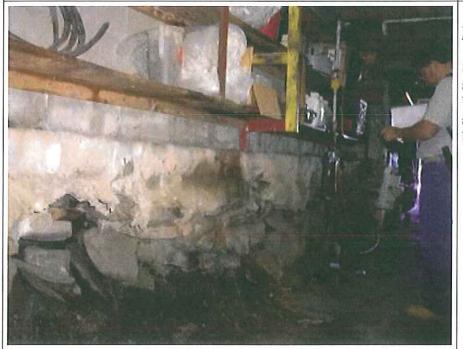
Photo 6

The original foundation is comprised of a stone rubble wall in Buildings A, C, and D, refer to first floor framing plan in Attachment 2. There is a 4-inch concrete cap on the stone rubble wall, forming a level surface to support the 8-inch block foundation to the underside of the wood framing, refer to photos 6 to 9. The original grade had been removed at the south and east foundation walls in order to increase the headroom for maintenance and storage. In doing so, the stone rubble foundation wall was exposed and no longer laterally braced by the excavated soil, refer to photos 6 and 7. This condition is unsafe and may result in movement of the stone rubble foundation wall. The lateral forces from ground water and saturated soils outside the building will apply pressure on the stone rubble foundation wall and may cause failure.

Stone rubble foundation supporting 8-inch concrete block, located at the south and east elevations of the building.

The existing exposed stone rubble foundation walls are presently unsafe. A reinforced concrete buttress foundation wall and footing should be installed to give lateral support and brace the stone wall.

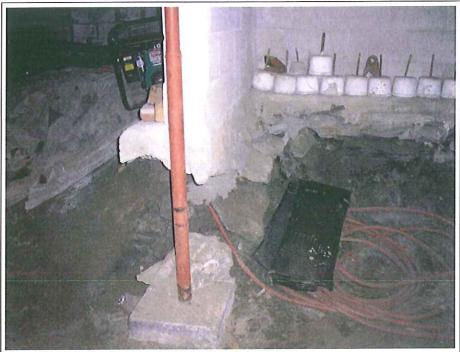
Photo 7

Stone rubble foundation supporting 8-inch concrete block, located at the south and east elevations of the building.

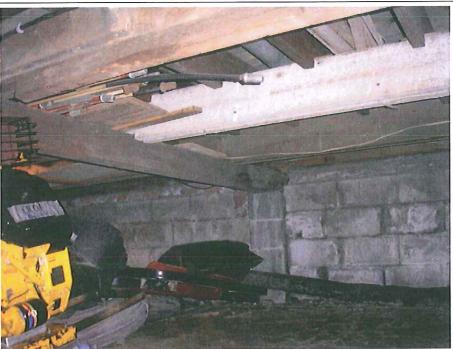
Photo 8

Typical 8-inch CMU foundation supporting first floor (main floor) framing in Building C.

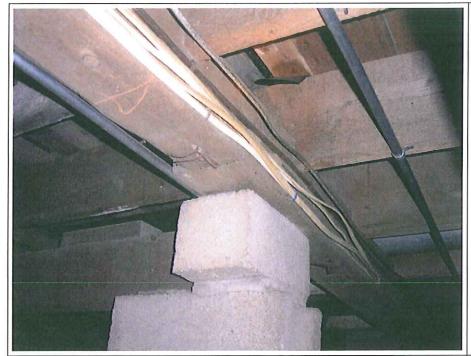
Photo 9

The first floor framing in the original building (A and C) is supported on the foundation wall and interior 8-inch concrete block piers, refer to photos 9, 10, and 11. The 8-inch concrete block piers are founded on small square concrete footings, refer to photos 10 and 11. The concrete footings and piers are located in areas where the original soils had been excavated and removed in order to gain more headroom. Soil beneath the footings for the concrete block piers at the edge of the excavated area may be unstable, creating an unsafe condition. The concrete block piers should be replaced with new steel columns properly supported on new concrete spread footings located below the grade.

Building A (the original building) first floor is framed with full size 2x8's (2 inches by 7 3/4 inches) at approximately 18 inches on center, refer to first floor framing drawings in Attachment 2. The 2x8 floor joists span approximately 14 feet in the east/west direction supported on a 6x6 wood beam. The beam is supported by 3 1/2-inch round (4-inch overall dimension) steel columns at approximately 8 to 10 feet on center. There is also a 6x6 wood beam supporting the 2x8 wood framing along the east elevation of Building A. The 6x6 wood beam is supported on concrete piers at approximately 10 feet on center, refer to photo 9.

The existing 2x8 first floor framing in Building A cannot support the required live loads assumed for public assembly. Based on our calculations, the 6x6 beam spanning 10 feet has the capacity to support approximately 40 pounds per square foot (psf) live load. The 2x8 full-size floor joists at 18 inches on center can also support about 40 psf.

8-inch concrete block supporting a 6x6 timber beam along the east wall of Building A.

The concrete block piers and supporting footings should be removed and new steel columns founded on properly sized spread footings should be installed below grade.

To increase the live load capacity to public assembly on the first floor in Building A, we recommend that additional columns, beams, and footings be installed for the both the floor joists and supporting beams.

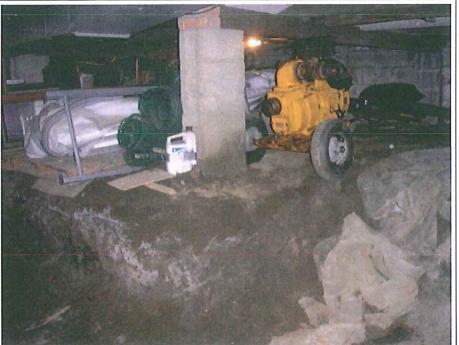
Photo 10

Exposed concrete footings supporting 8-inch concrete block piers located at the east side of Building A, supporting the first floor (main floor) framing.

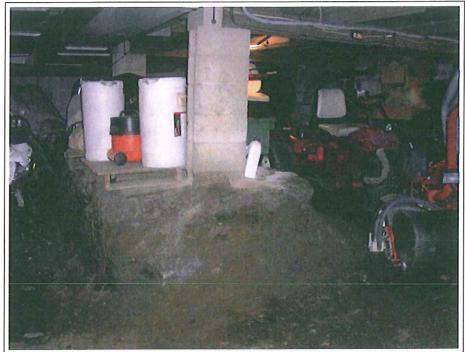
Photo 11

Exposed concrete footings supporting 8-inch concrete block piers located at the east side of Building A, supporting the first floor (main floor) framing.

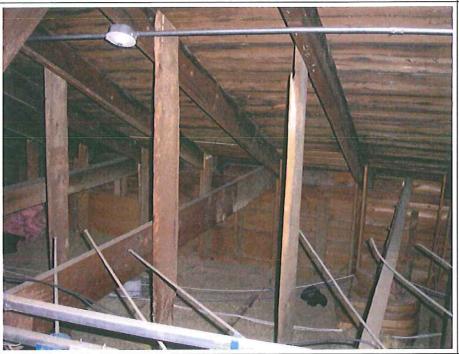
Photo 12

The roof framing in Building A consists of 2x6 rafters at approximately 24 inches on center. The roofing is supported on 1x boards, varying in width from 4 to 8 inches. The ceiling below the roof rafters is hung by 1x8 vertical boards at quarter-span attached to the 2x6 roof rafters. The 2x6 roof rafters at 24 inches on center are not capable of supporting the required 30 psf snow load for the Town of Jamestown.

Full 2x6 rafters at 24 inches on center, typically found in the main building.

The existing 2x6 rafters would have to be sistered with an additional framing in order to meet the snow load requirements.

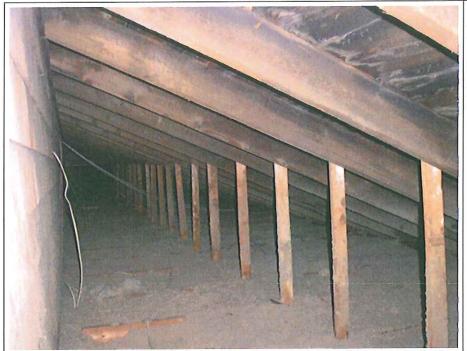
Photo 13

The roof framing in Buildings B and C is comprised of full 2x6 rafters at approximately 24 inches on center, refer to photo 13. Similar to Building A, the 2x6 rafters in Buildings B and C are not in compliance with the live load requirements for the Town of Jamestown.

2x6 rafters at 18 inches on center, typically found in Building C.

The existing 2x6 rafters in Buildings B and C would need to be sistered with additional framing at each existing 2x6 joist.

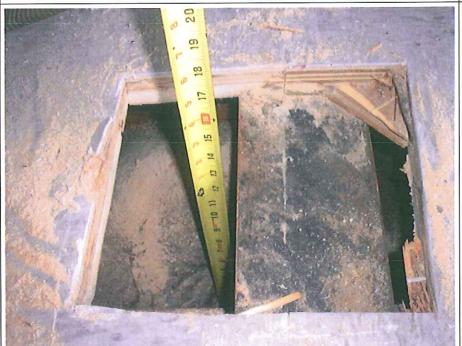
Photo 14

The first floor framing in Building E is comprised of two 12-inch steel beams spanning north to south at approximately third points across the building, refer to photo 14. There are 2x12-inch floor joists at 16 inches on center spanning in the east to west direction between the steel beams and the exterior walls. Our analysis shows that the live load capacity of the first floor framing in Building E, above the restaurant, is about 50 psf live load.

12-inch steel first floor beams supporting 2x12 framing in the east building.

In order for the first floor framing in Building E to support the live load required for public assembly, new steel columns and footings would have to be installed at mid-span of the two existing steel beams. Secondly, in the middle bay, each 2x12 floor joists would need to be sistered with an additional 2x12 joist.
